3.0 JURISDICTIONAL WATERS INVESTIGATION

**PRELIMINARY JURISDICTIONAL
DETERMINATION OF WETLANDS
AND OTHER WATERS
FOR
KROGER N-549
US 36/33 AND WEST 5TH ST
MARYSVILLE, UNION COUNTY, OHIO**

**MAY 2013
(REVISED MAY 2014)**

APPENDIX B
Site Photographs

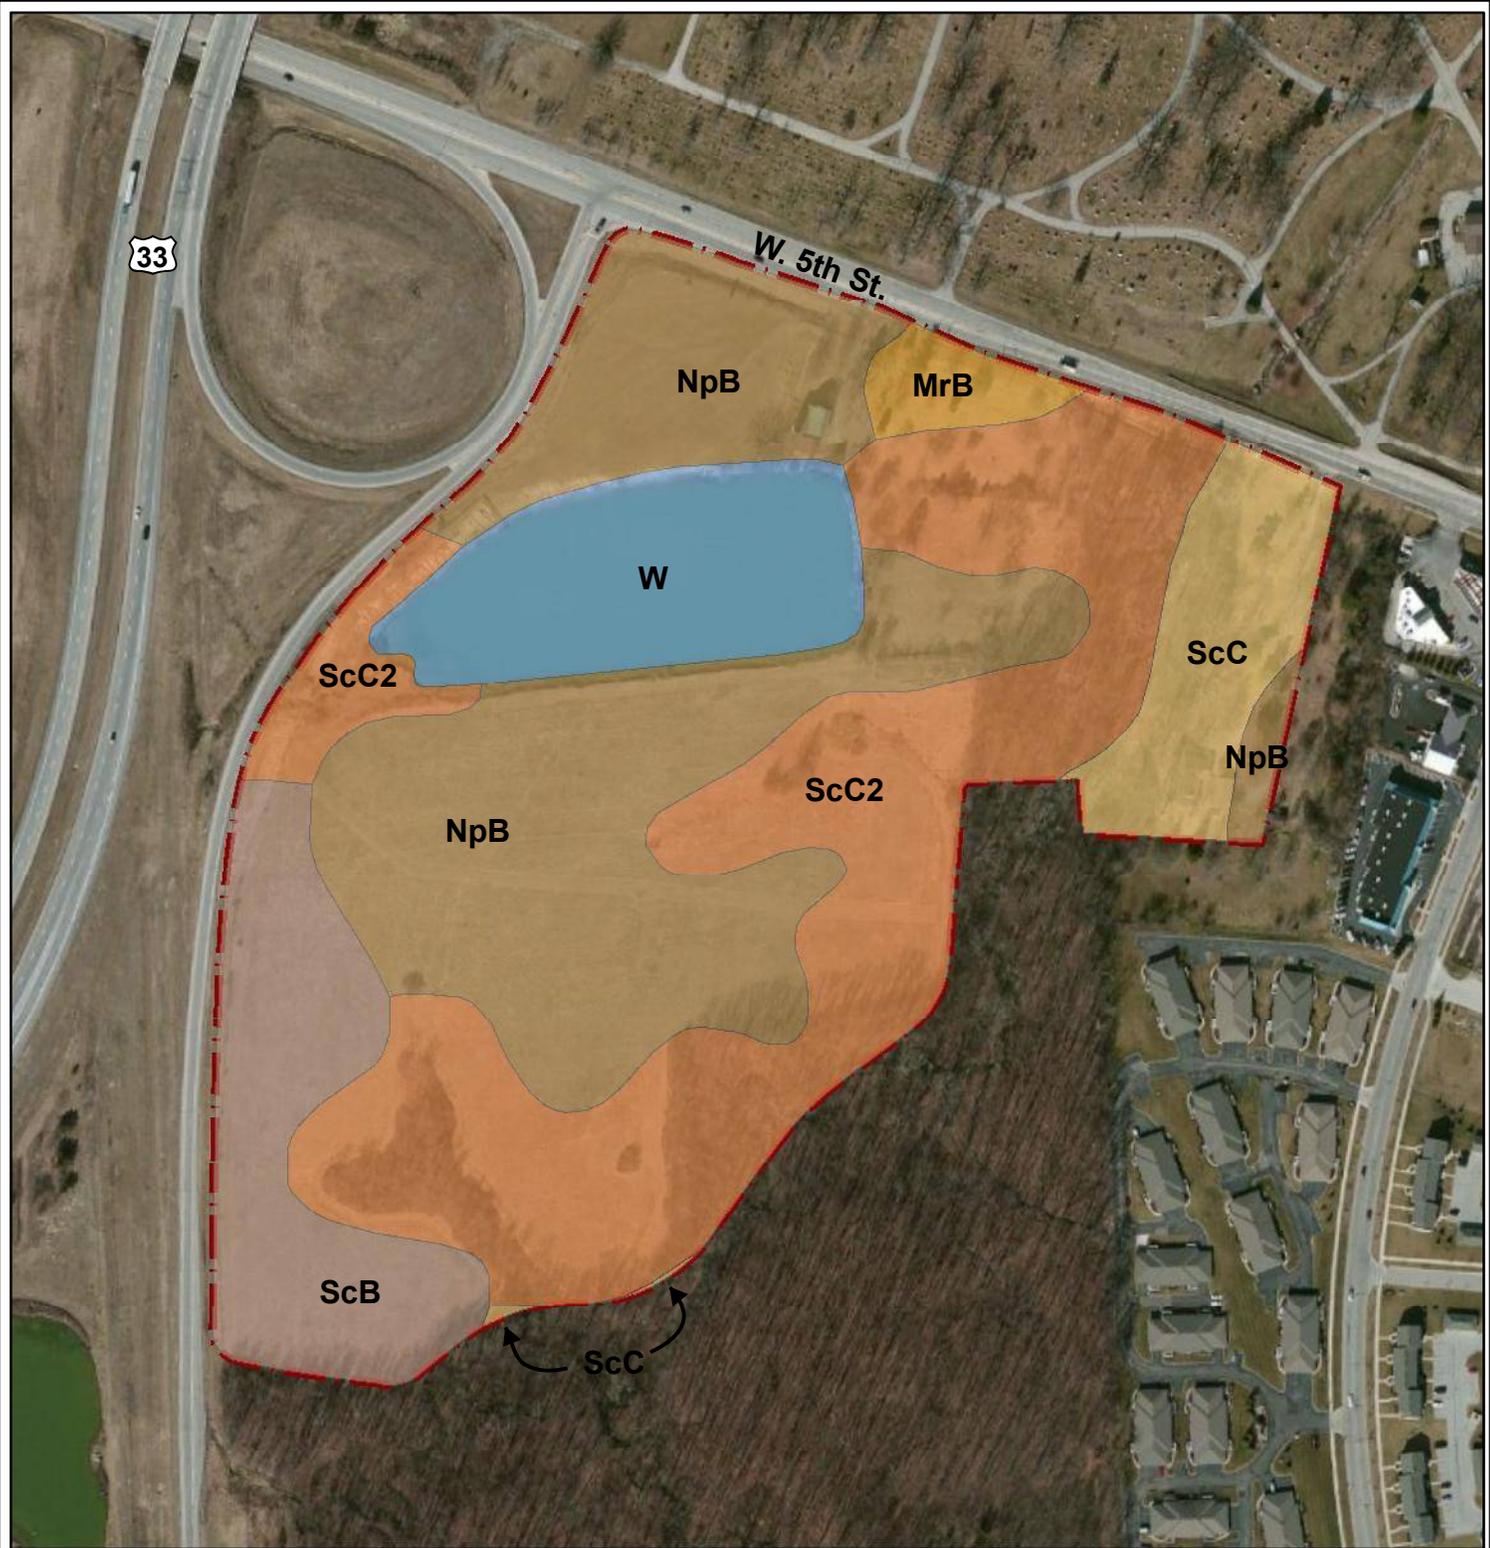
- Delineation Boundary
- MrB - Morley silt loam, 2-6 % slope
- NpB - Nappanee silt loam, 2-6 % slope
- ScB - St. Clair silt loam, 2-6 % slope
- ScC - St. Clair silt loam, 6-12 % slope
- ScC2 - St. Clair silt loam, 6-12 % slope, eroded
- W - Water

According to the Web Soil Survey, there are five mapped soil types within the project area, as illustrated in **Figure 3**. A brief description of the five soil types (from most to least abundant) is found below (NRCS 2013; NRCS 2012):

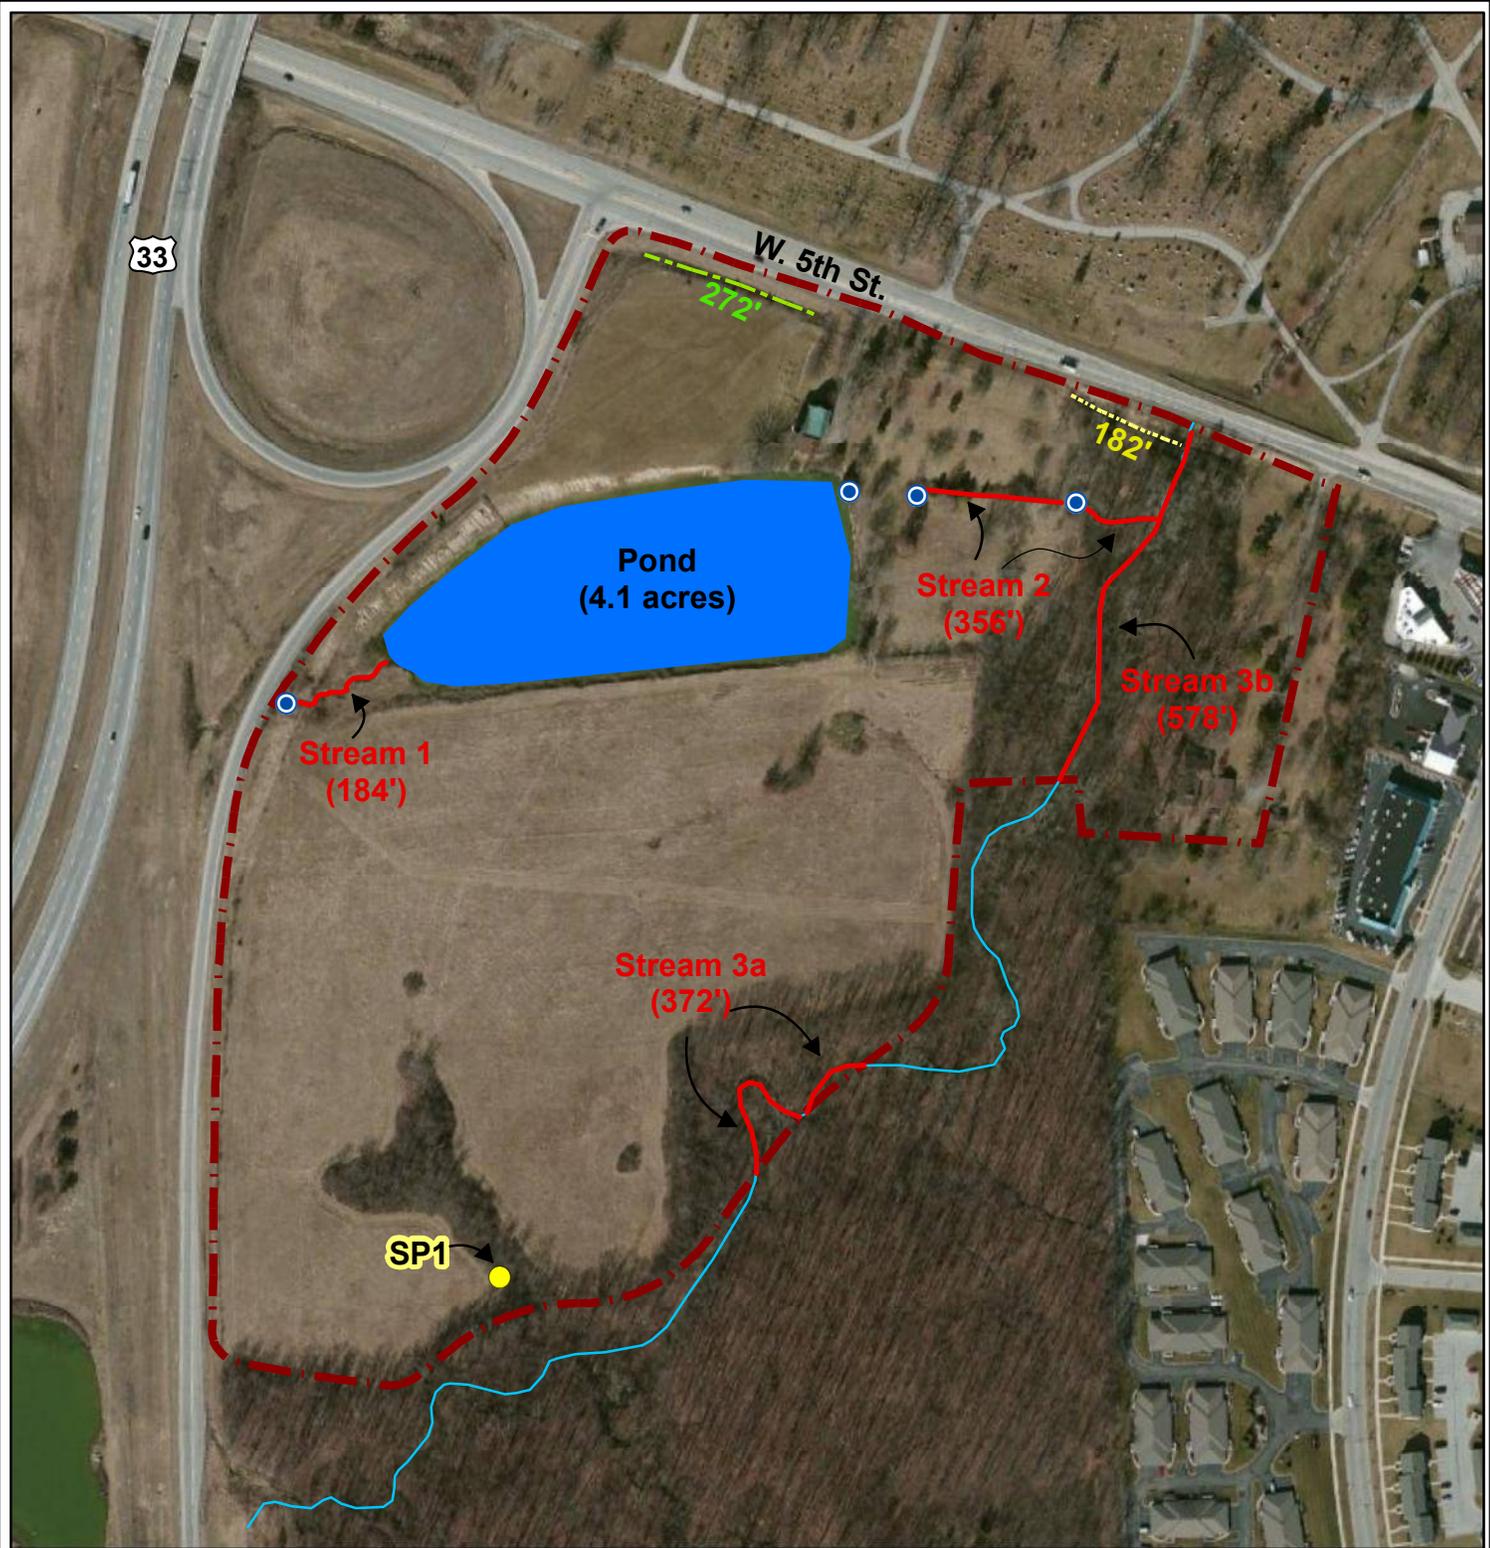
- Culvert
- Wetland Determination Point
- Potential Stream Impact
- Roadside Ditch
- Concrete Conveyance
- Stream
- Pond
- Delineation Boundary

Based on AMEC's site reconnaissance, no wetlands occur within the 40-acre project area. One small area in the southern portion of the site, identified as SP1 on **Figure 5**, exhibited hydrological indicators, including drainage patterns and water stained leaves. While some drainage appears to occur in the lower portion of this narrow wooded area, it appears to flow fairly quickly through this area toward the unnamed tributary to Mill Creek. No defined bed and bank were observed. In addition, the area did not meet hydric soil or hydrophytic wetland vegetation criteria (see **Photograph 1** in **Appendix B**). A copy of the Wetland Determination Data Form – Midwest Region documenting site characteristics within this area is provided in **Appendix A**.

While no wetlands were observed, other surface waters were documented on the property. Surface waters observed on the property are summarized in **Table 1** and illustrated on **Figure 5**. Additional information on these features is provided below.

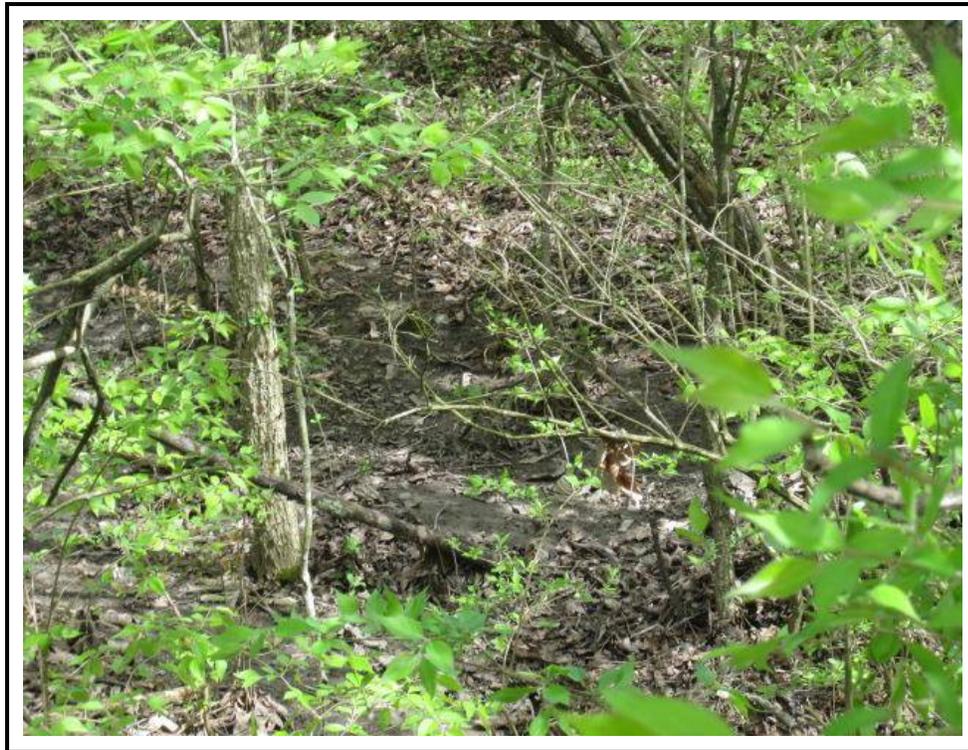
Photo 1
View of SP1 within the southern portion of the narrow wooded area extending northeast near the bottom of the property.
May 2, 2013

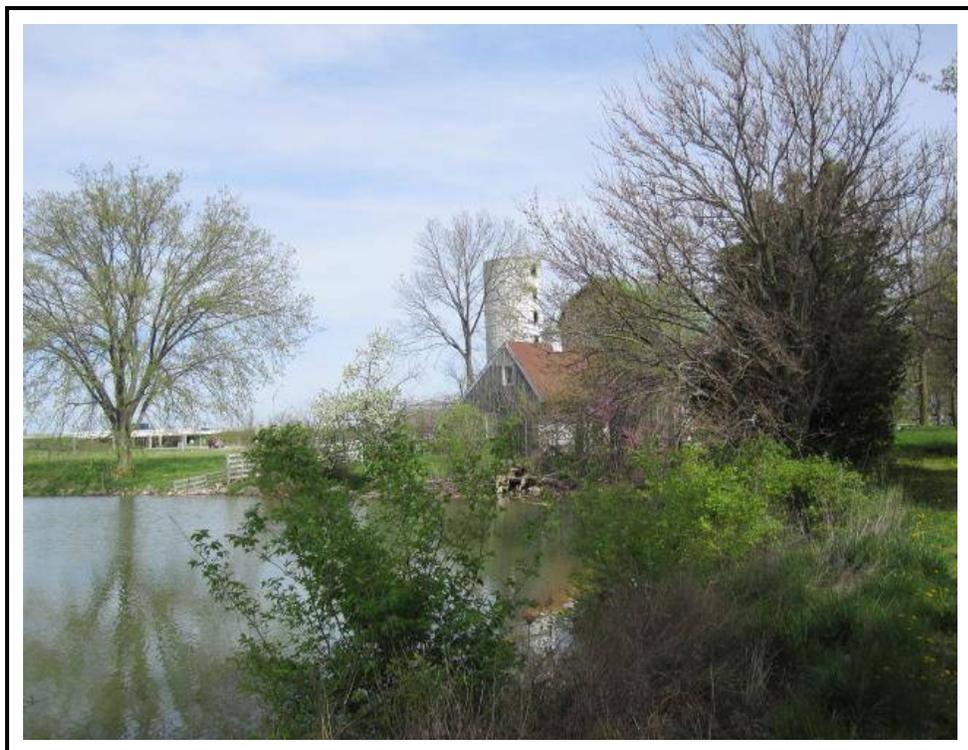
Photo 2
Looking north from the southeast corner of the pond.
May 2, 2013

The approximately 4.1-acre pond identified on NWI and Ohio Wetland Inventory mapping was observed on-site. With the exception of a narrow riparian corridor along the eastern side of the pond with upland species (e.g., amur honeysuckle [*Lonicera macckii*], multiflora rose [*Rosa multiflora*], autumn olive [*Elaeagnus umbellata*]), the pond was devoid of a riparian corridor. The banks of the pond were displaying signs of moderate to severe erosion particularly along the northern bank (see **Figure 5** and **Photographs 2 – 5** in **Appendix B**).

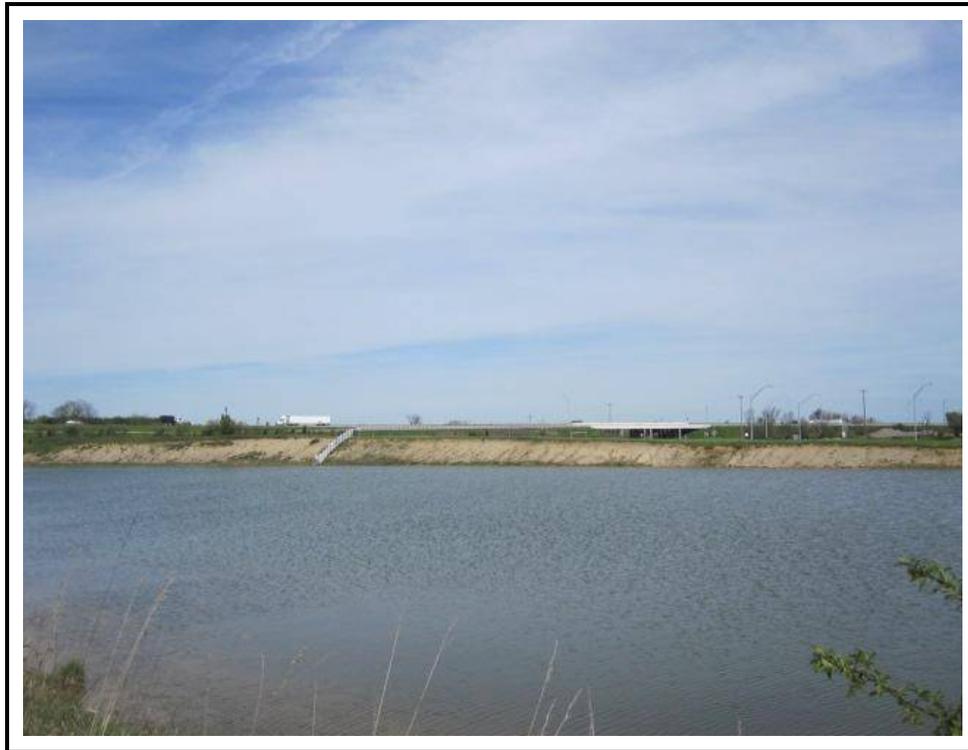
Photo 3
View of the pond looking
north.
May 2, 2013

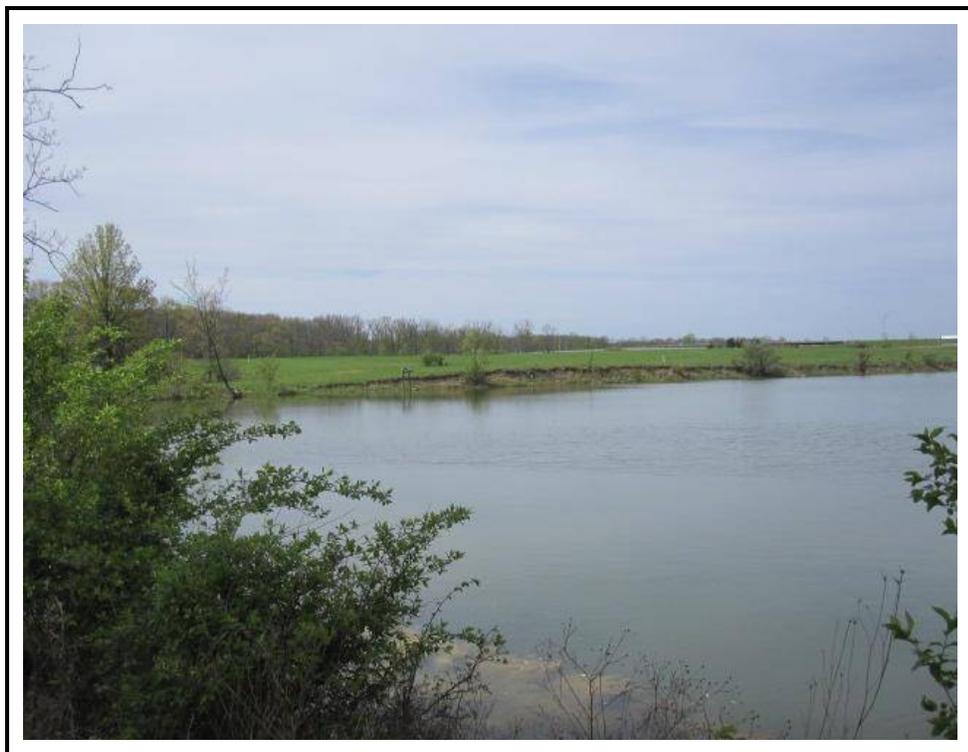
Photo 4
View of the pond looking
west.
May 2, 2013

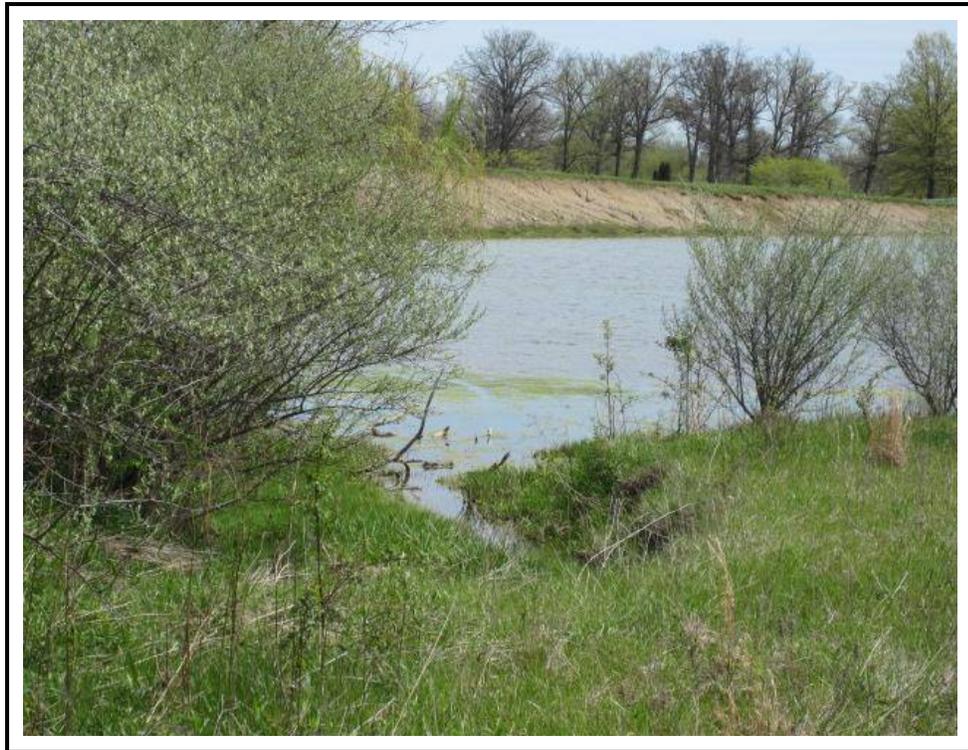
Photo 5

View facing northeast along the western bank of the pond. The small drainage (Stream Segment 1) west of the pond is seen in the foreground where it converges with the pond. May 2, 2013

A small drainage channel with a defined bed and bank was observed west of the pond that had flowing water in it at the time of the site visit. The channel started at the culvert beneath US 36/33, and extended east approximately 184 feet before entering the pond. An oil sheen was observed within this drainage channel. Vegetation along the banks was fairly sparse, but generally consisted of amur honeysuckle, multiflora rose, and bull thistle (*Cirsium vulgare*). Water levels were 6 inches at the time of the site visit, and the width of the channel at the ordinary high water mark (OHWM) was approximately 1-foot. The channel substrate consisted of silt and clay (see **Figure 5** and **Photographs 5 – 6** in **Appendix B**).

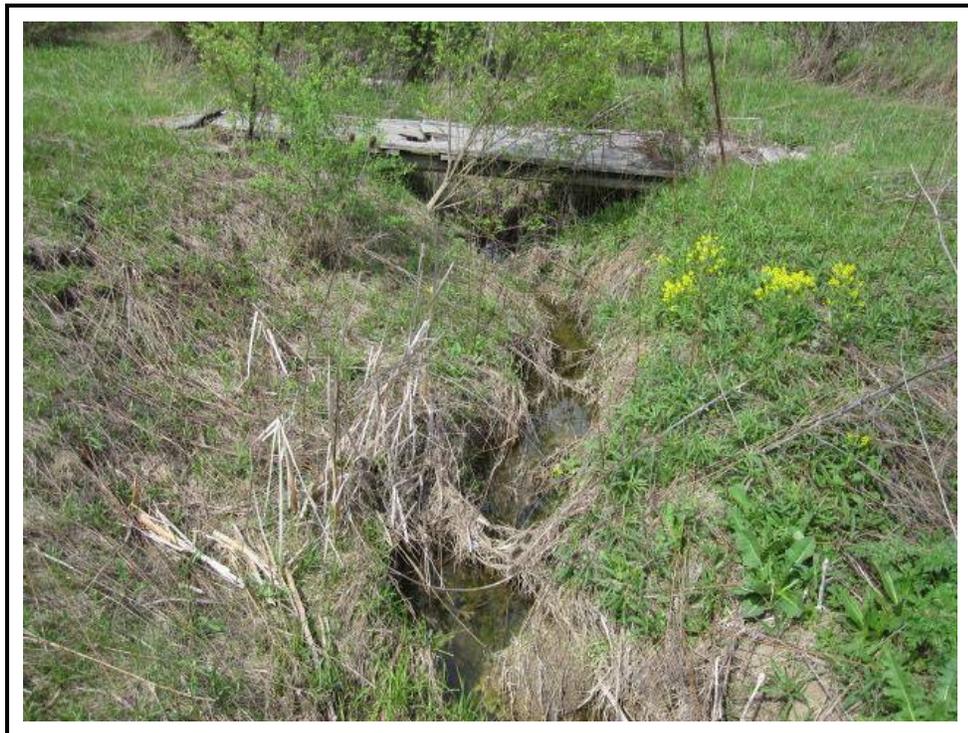
Photo 6

View of the drainage channel (Stream Segment 1) located west of the pond facing west. May 2, 2013

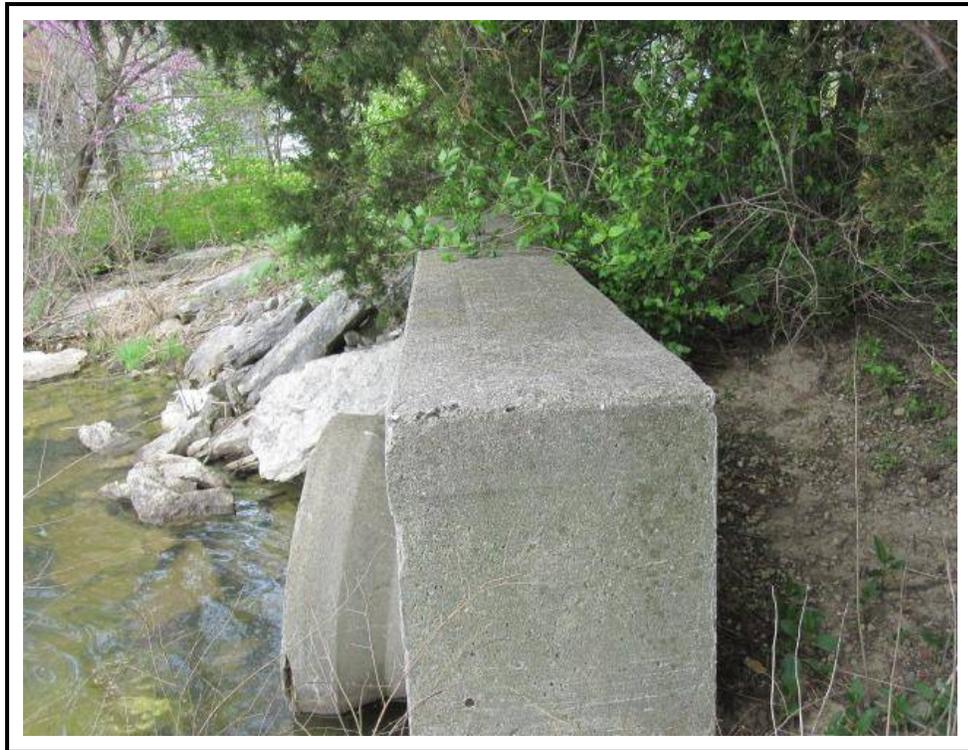
Photo 7
View of culvert looking
north along the east bank
of the pond.
May 2, 2013

A small drainage channel with a defined bed and bank was also observed approximately 100 feet from the eastern boundary of the pond. An overflow outlet culvert for the pond was observed at the edge of the pond that outlets where the stream channel begins again. The culvert was likely placed to accommodate the trail within this portion of the project site. The channel extends east approximately 221 feet before entering another small culvert (approximately 15 feet) that appears to be placed to also accommodate vehicle passage. This channel daylighted and continues east for another 43 feet on the property, eventually converging with the unnamed tributary to Mill Creek outside the project area. Water levels were approximately 2 inches at the time of the site visit and concentrated in the center of the channel. The width of the channel at the OHWM ranged from approximately 1 to 3 feet. A narrow riparian corridor was present in some portions of the drainage channel. The channel substrate consisted of silt with some woody debris (see **Figure 5** and **Photographs 7 – 12** in **Appendix B**).

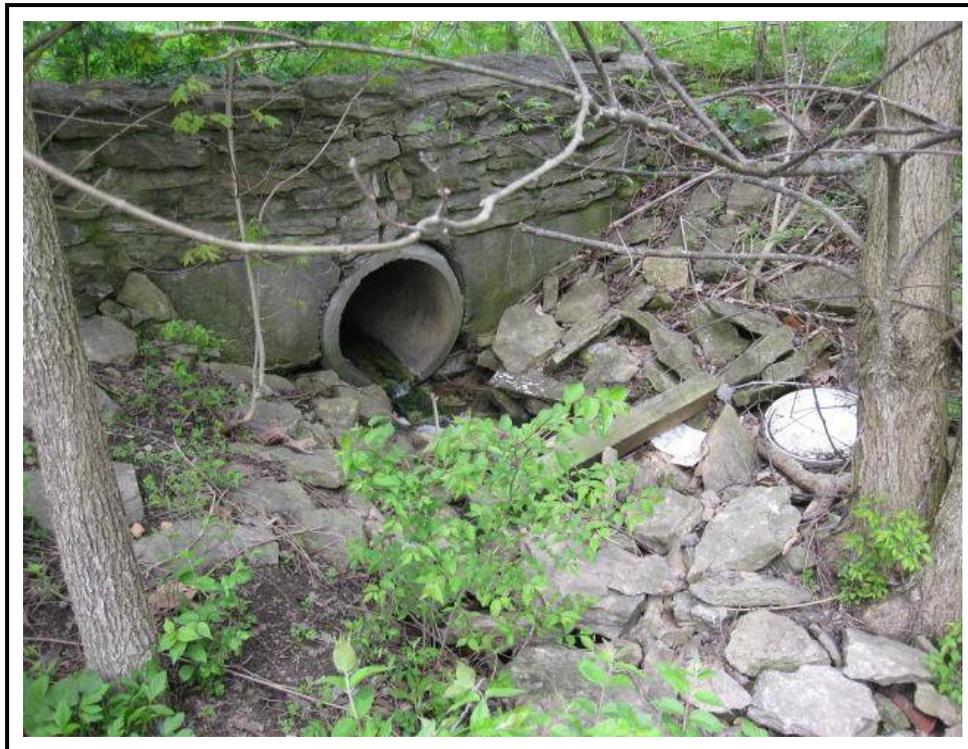
Photo 8
View of culvert outlet
approximately 100 feet
east of pond. Drainage
channel east of the pond
initiates here (Stream
Segment 2).
May 2, 2013

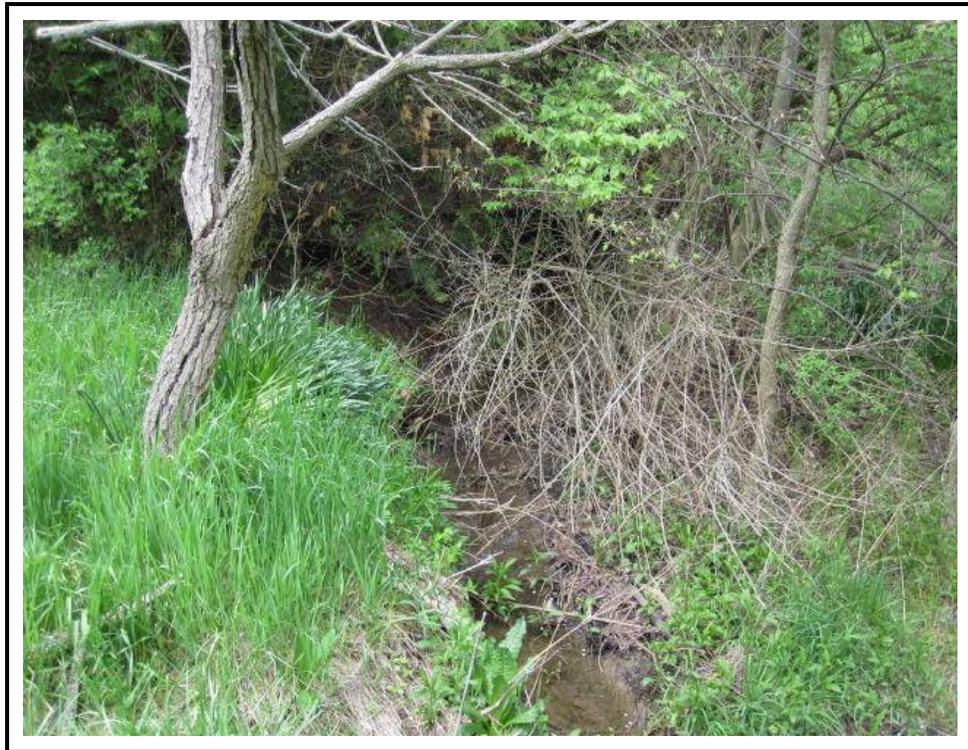
Photo 9
View of drainage channel
east of pond looking west
(Stream Segment 2).
May 2, 2013

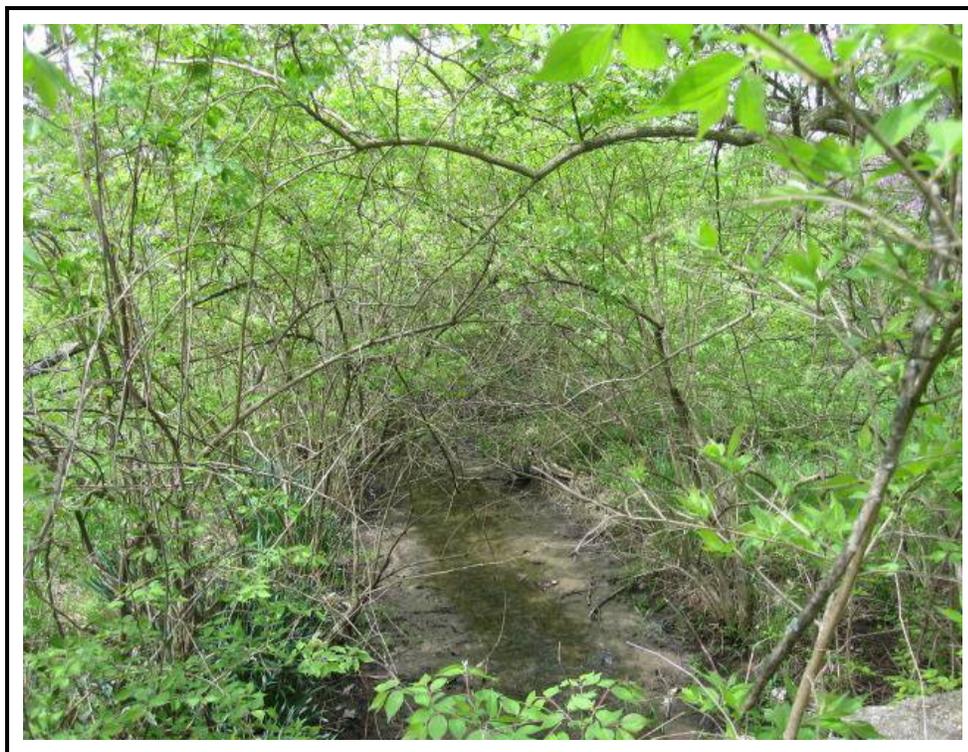
Photo 10
View of drainage
channel east of pond
taken near the center of
the drainage looking west
(Stream Segment 2).
May 2, 2013

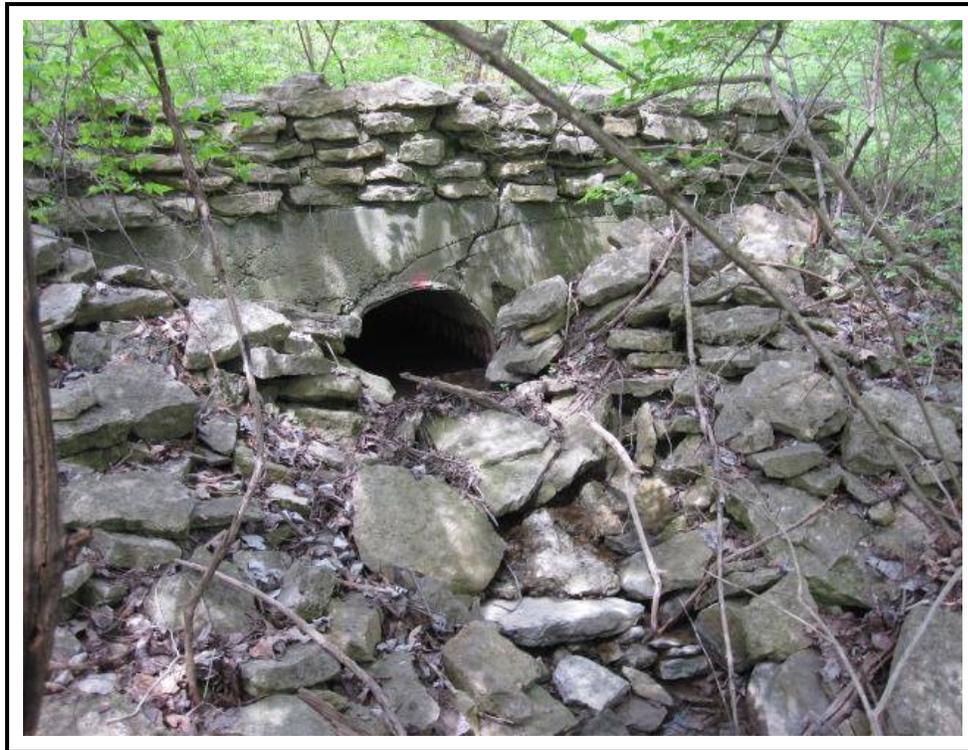
Photo 11
View of culvert near the eastern property boundary looking west (Stream Segment 2) .
May 2, 2013

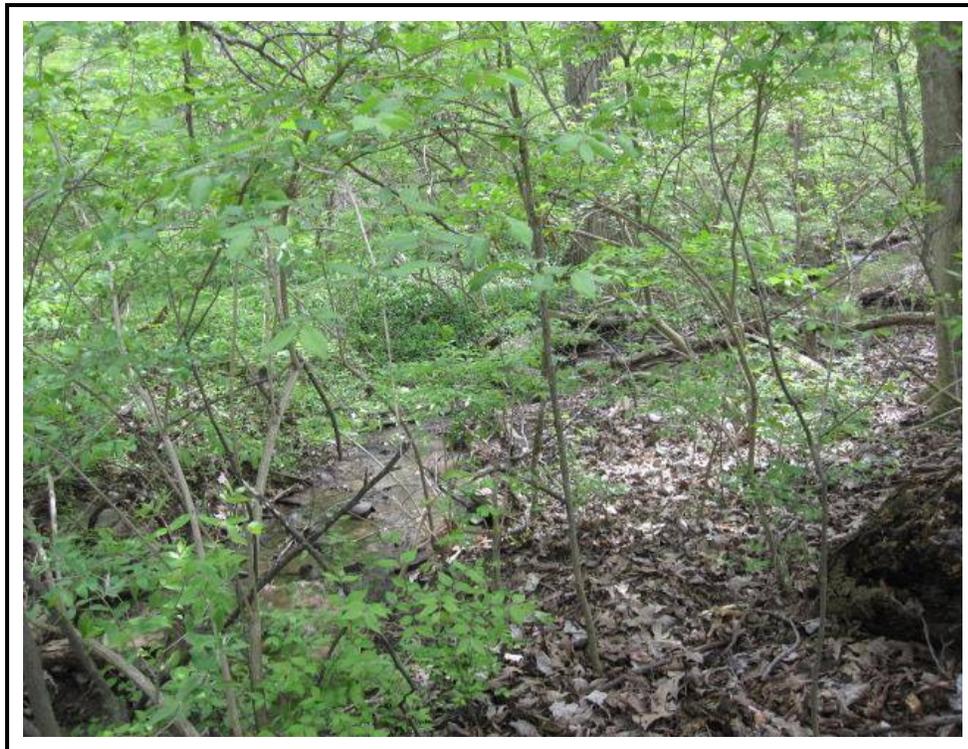
Photo 12
View of drainage channel looking east near the eastern property boundary (Stream Segment 2) and its confluence with the unnamed tributary to Mill Creek (Stream Segment 3b).
May 2, 2013

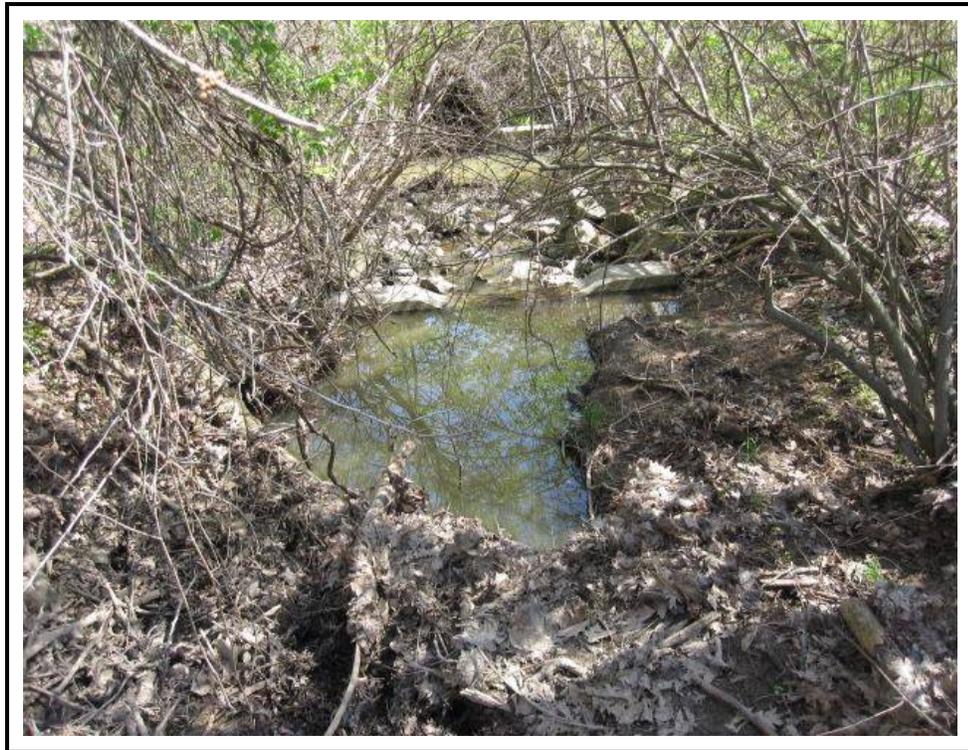
Photo 13
View of unnamed
tributary to Mill Creek
(Stream Segment 3b)
looking downstream
(north) at the culvert
under West 5th Street.
May 7, 2014

Approximately 454 feet of the unnamed tributary to Mill Creek (Stream Segments 3a and 3b) depicted as an intermittent blue line stream on the USGS topographic map occurs within the project area. The remainder of this stream lies outside the project area, but in some cases it meanders immediately adjacent to the property boundary. Water levels were approximately 6 inches at the time of the site visits in both Stream Segments 3a and 3b, and the width of the channel at the ordinary high water mark (OHWM) was approximately 5 to 6 feet in Stream Segment 3a and approximately 10 to 12 feet wide in Stream Segment 3b. The substrate consisted of cobble, gravel, silt, and woody debris (see **Figure 5** and **Photographs 13 – 18** in **Appendix B**). This stream has a relatively wide riparian corridor. Vegetation within the riparian corridor is described in **Section 3.2** below.

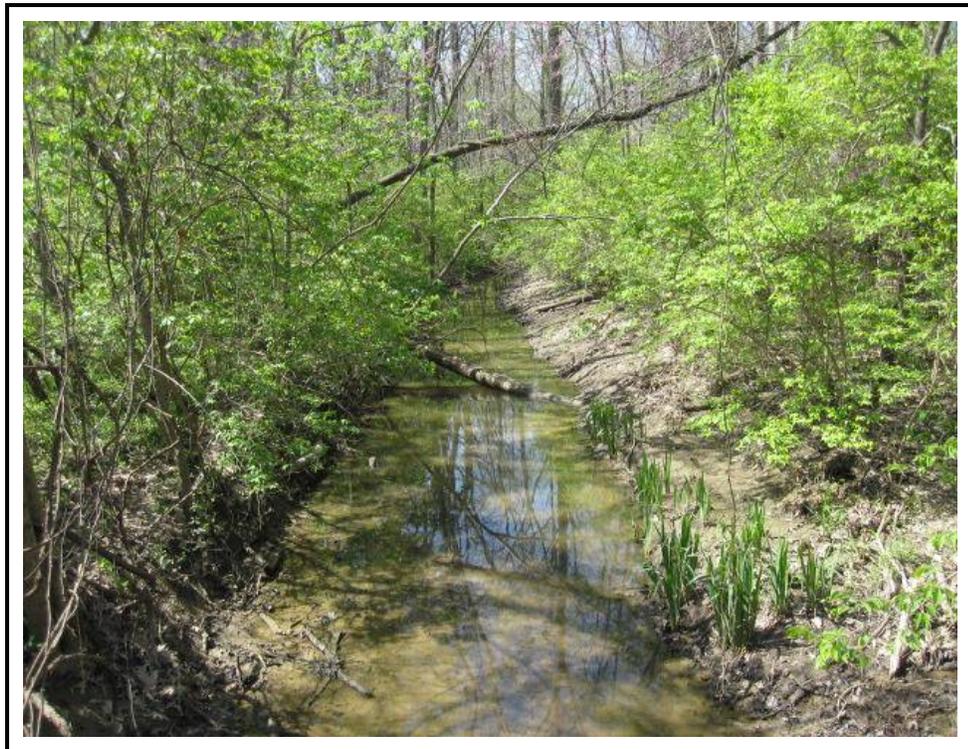
Photo 14
View of unnamed
tributary to Mill Creek
(Stream Segment 3b)
looking upstream (south)
May 7, 2014

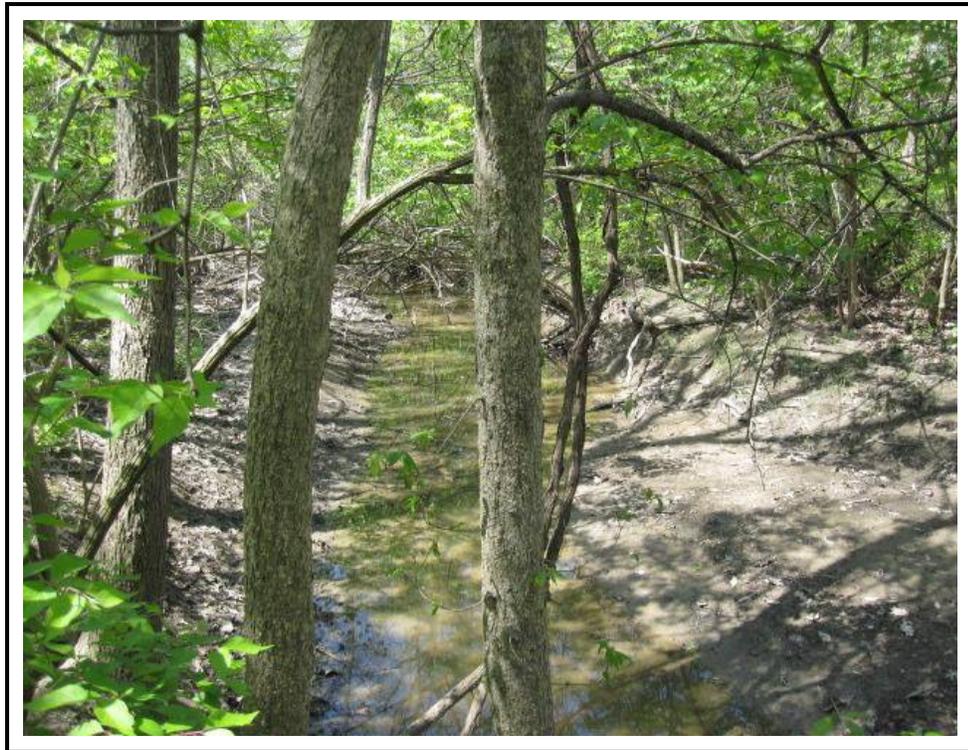
Photo 15
View of unnamed
tributary to Mill Creek
(Stream Segment 3b)
looking upstream (south)
approximately 300 feet
south of West 5th Street
May 7, 2014

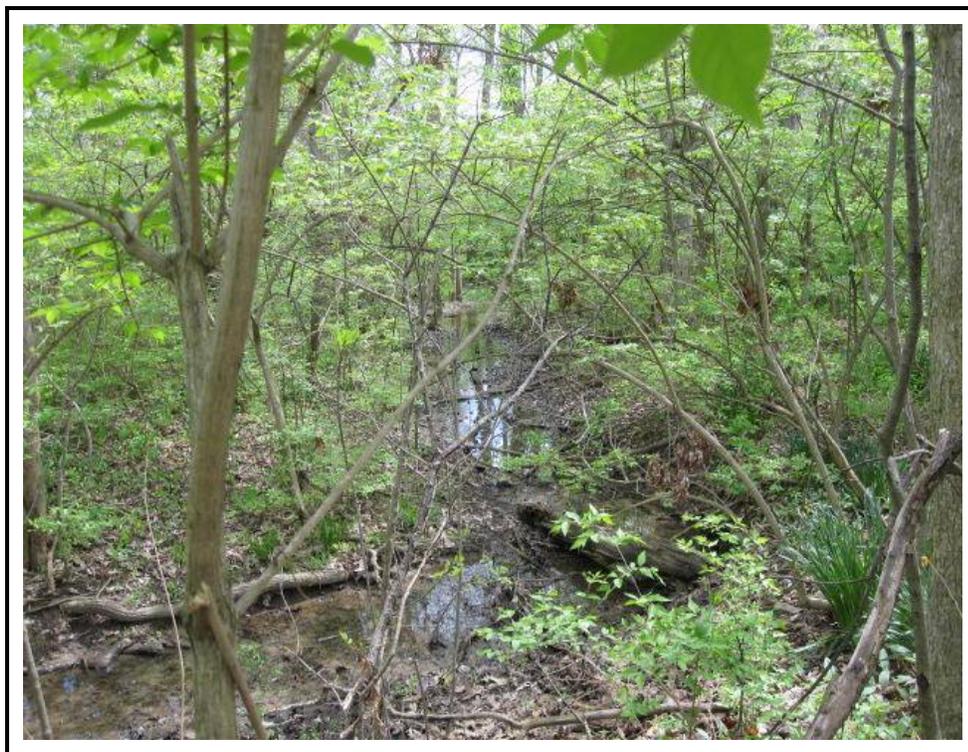
Photo 16
View of unnamed
tributary to Mill Creek
from the left bank (west).
Picture was taken
outside the property
within the central portion
of this stream.
May 2, 2013

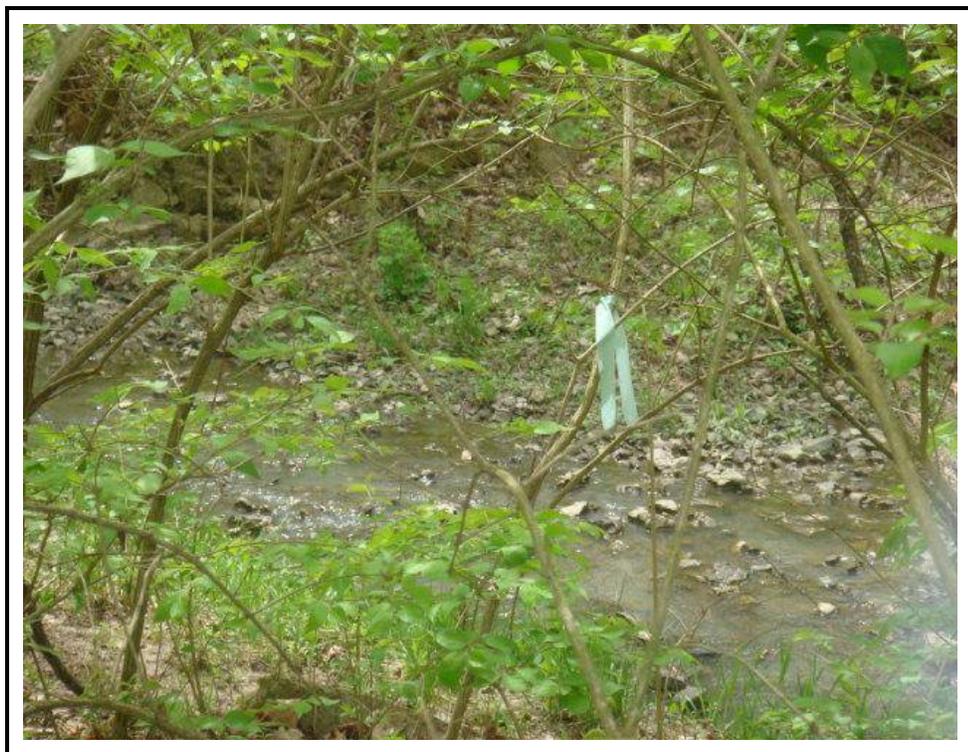
Photo 17
View of unnamed
tributary to Mill Creek
from the left bank (west).
May 2, 2013

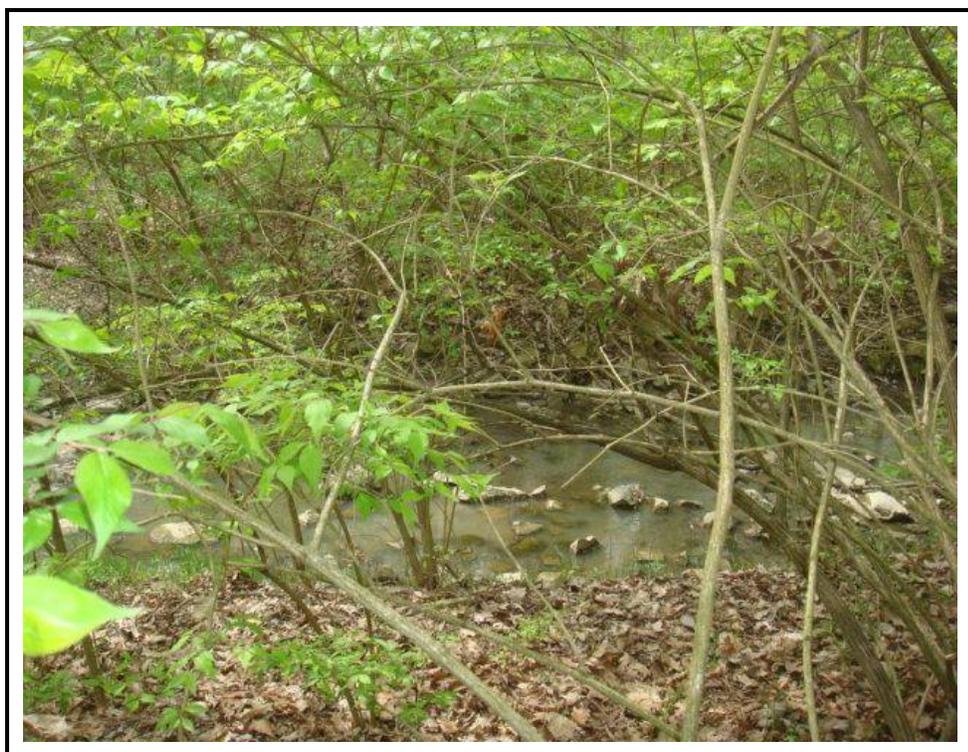
Photo 18
View of unnamed
tributary to Mill Creek
from the left bank (west).
May 2, 2013

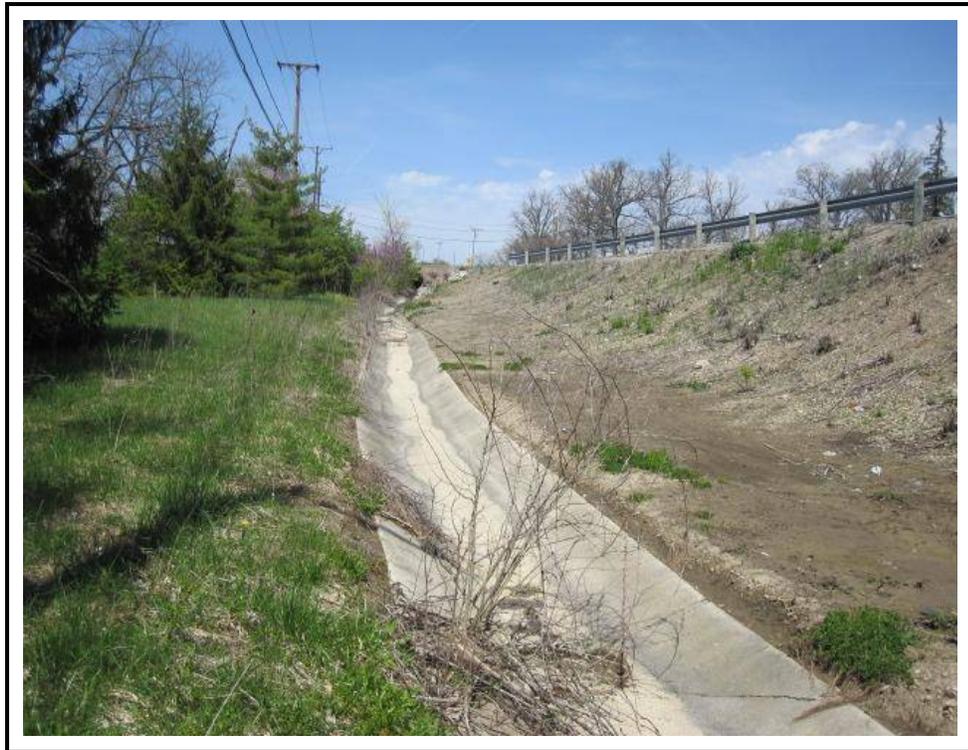
Photo 19

View of concrete stormwater conveyance within West 5th Street right-of-way that occurs in the northeastern portion of the project area.

Two drainage features were observed within the West 5th Street right-of-way that convey stormwater, which include an approximately 272-foot roadside ditch in the northwestern corner of the project area and an approximately 182-foot a concrete stormwater conveyance in the northeastern portion (see **Figure 5** and **Photographs 19-21** in **Appendix B**).

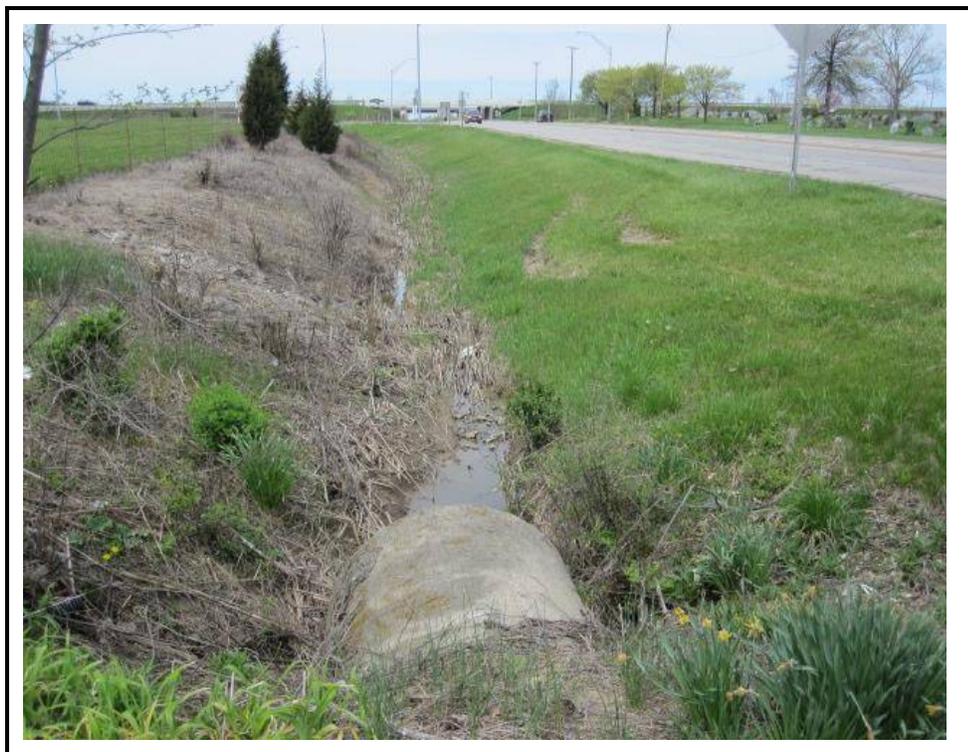
Photo 20

View of drainage ditch outside of property within West 5th Street right-of-way. The drainage ditch begins near the driveway accessing the project area and extends westward. This drainage area does not extend east. Drainage flows underground east of the driveway until it eventually empties into the unnamed tributary to Mill Creek just south of the roadway.

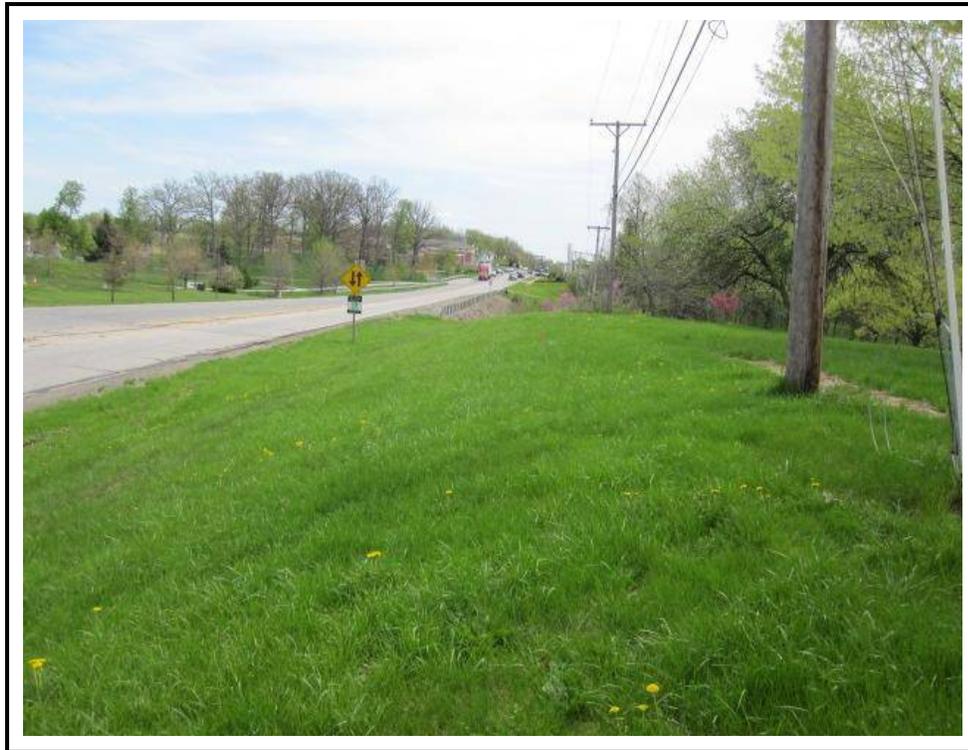
Photo 21
View of immediately south of West 5th Street from the driveway entering the project site. Note that the drainage ditch in prior picture is no longer visible.
May 2, 2013

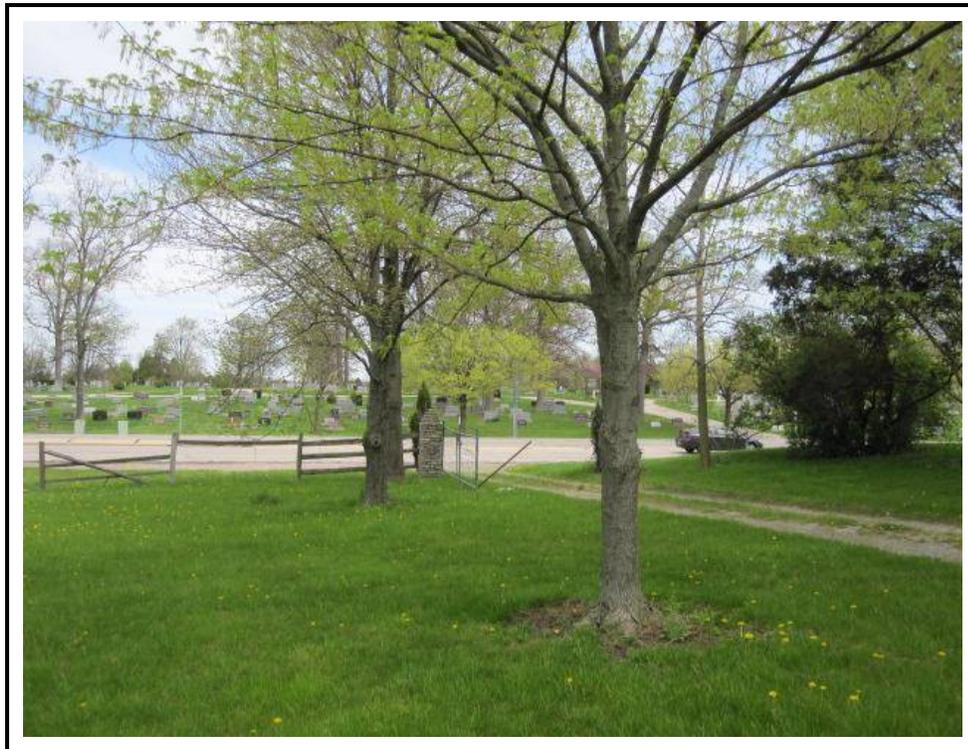
Photo 22
View of gravel driveway at the entrance of the property on West 5th Street looking north.
May 2, 2013
