3.0 JURISDICTIONAL WATERS INVESTIGATION

**PRELIMINARY JURISDICTIONAL
DETERMINATION OF WETLANDS
AND OTHER WATERS
FOR
KROGER N-549
US 36/33 AND WEST 5TH ST
MARYSVILLE, UNION COUNTY, OHIO**

**MAY 2013
(REVISED MAY 2014)**

APPENDIX B
Site Photographs

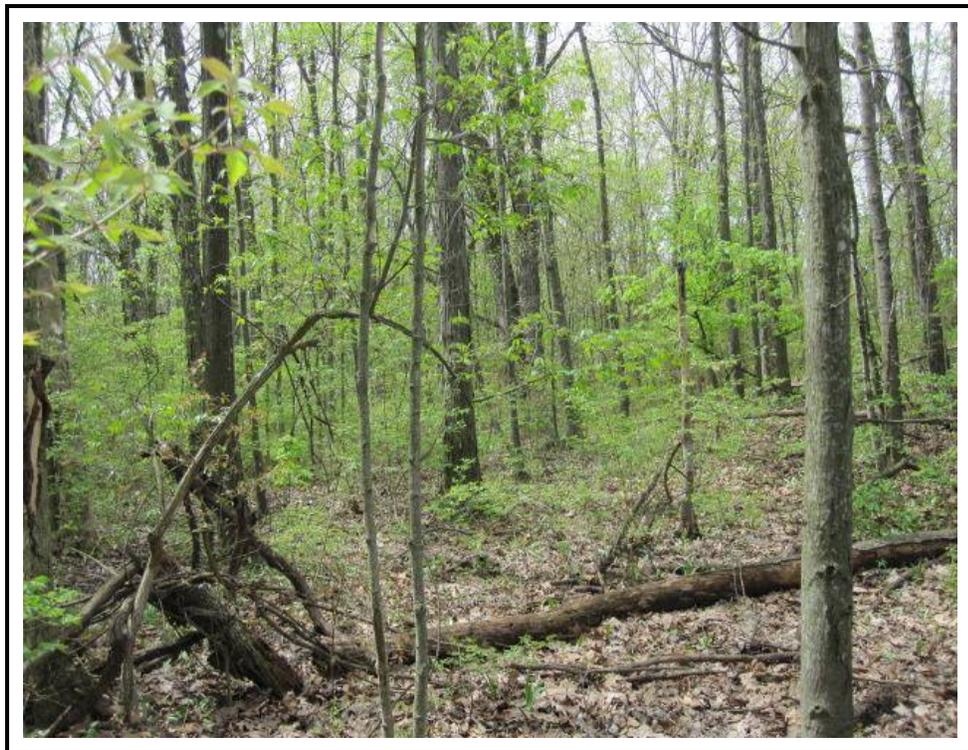
Photo 29
View of wooded riparian corridor of unnamed tributary to Mill Creek. The picture was taken along the eastern property boundary.
May 2, 2013

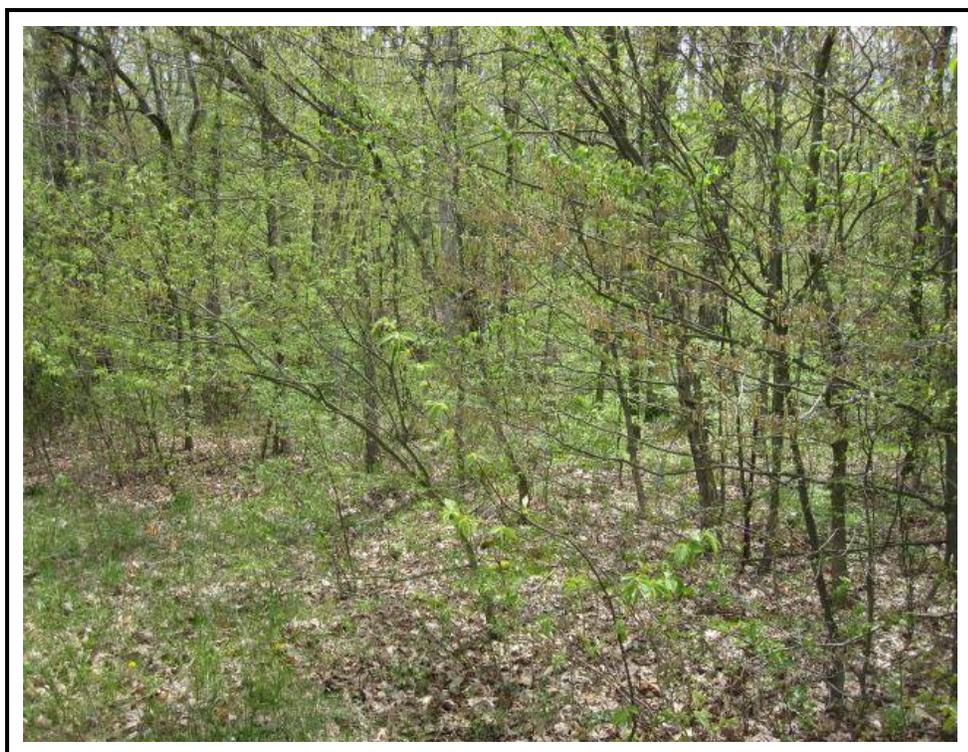
Photo 30
View of wooded riparian corridor of unnamed tributary to Mill Creek. The picture was taken along the eastern property boundary.
May 2, 2013

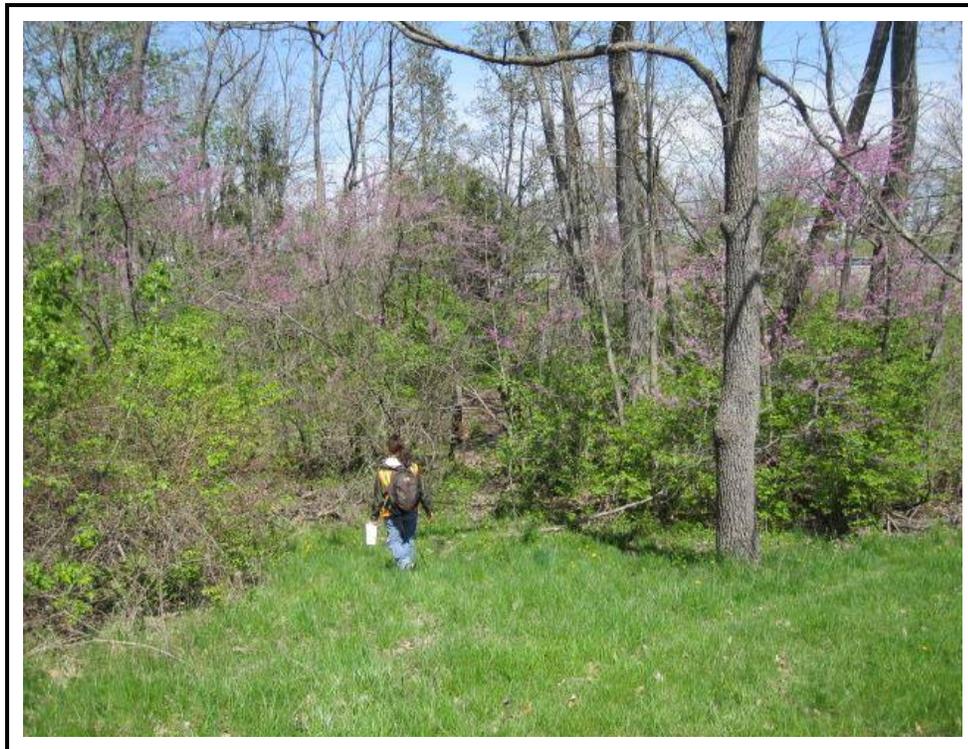
Photo 34

View along the eastern boundary of the project area looking west at the riparian corridor of the unnamed tributary to Mill Creek.
