TETLP OPEN PROJECT STREAM SUMMARY

OPEN Facility: 30" 36" MP: 62.9 Compressor Station
 Observers: Mike Lychwala, Jim Bolduc Date: 6/21/12
 Town: mead & York Townships County: Belmont County
 Crossing Name/ID: R12-7-51 (1-21) Recent Rain Event (date/amount): _____

Primary Headwater Habitat Evaluation Form

**OPEN 30" Mainline Waterbody Photographs
Belmont County, Ohio**

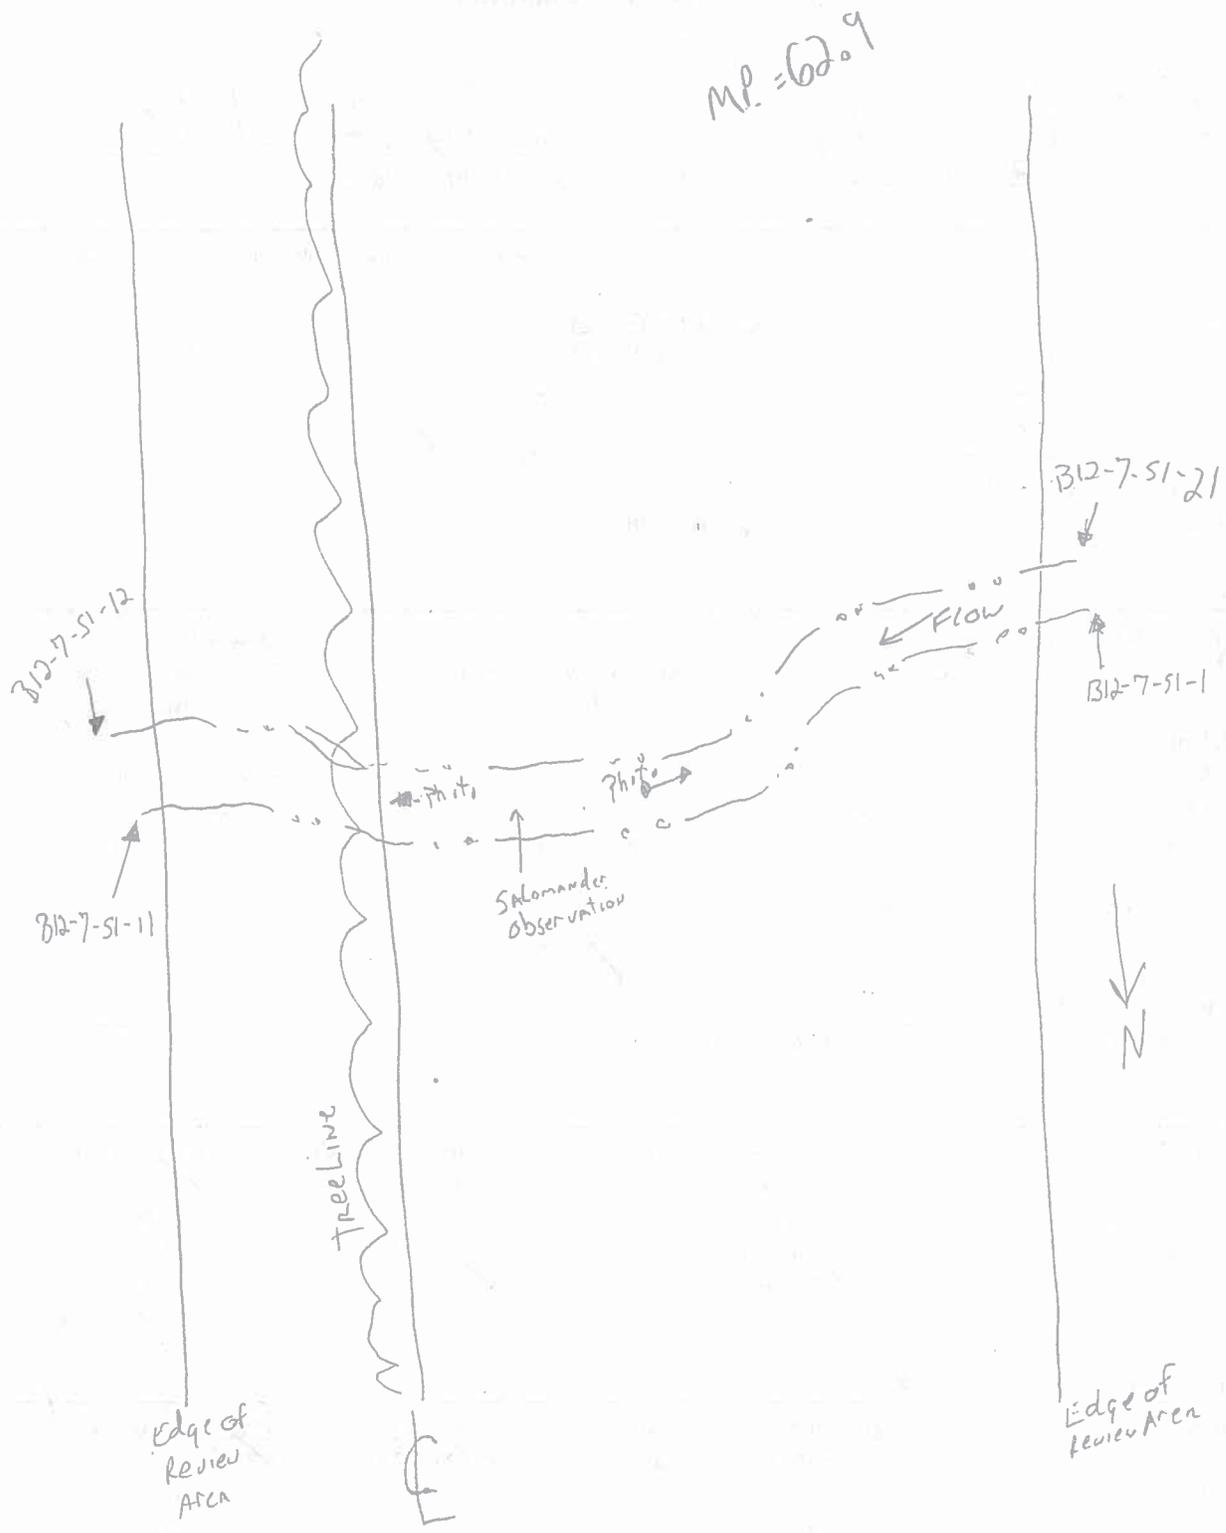
STREAM SKETCH

- Checklist:
- Stream ID# = ~~B12-7-51~~ B12-7-51 (1-21)
 - North arrow.
 - Detailed sketch of stream (Riffle, Run, Pool).
 - Natural and man-made features – roads, culverts, outcrops, structures, etc.
 - Photo locations.
 - Location of important wildlife sign.

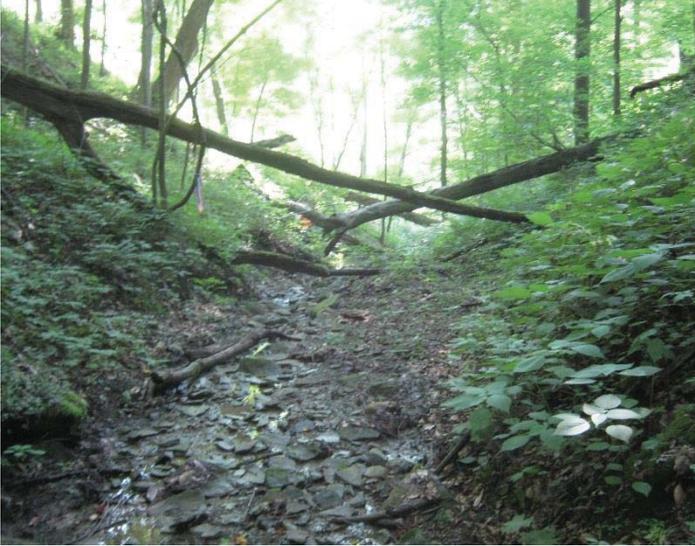
Photo 1	Photo 2

Photo 1: Intermittent stream, looking upstream to the west
